## Windstorm Mitigation Report (OIR-B1-1802)

The Cloisters At Bardmoor Condominium Association, Inc.

10811 Indian Hills Ct, Units 35-42

As of 01-05-2026 | FPAT File# MUD2525974

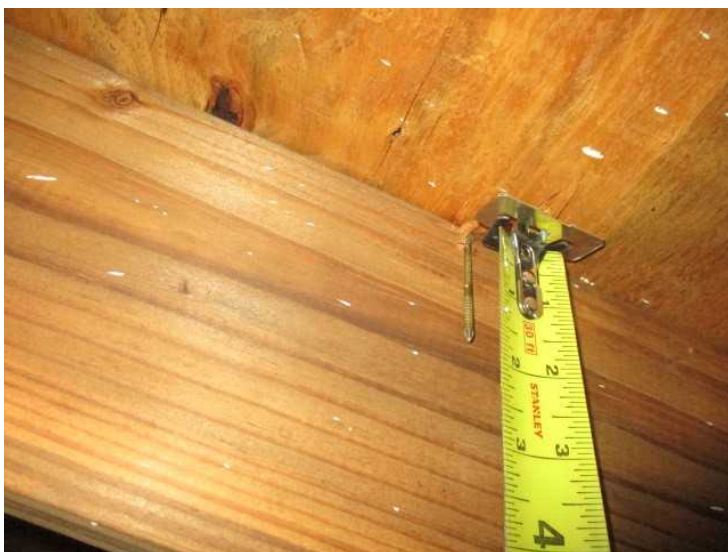
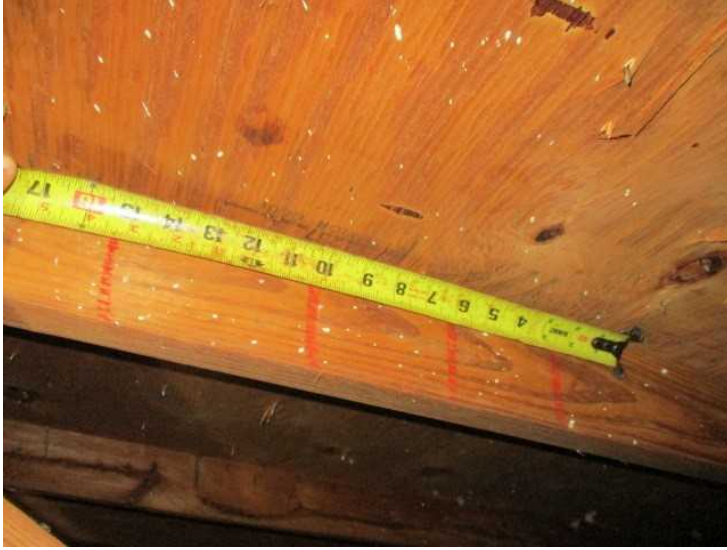
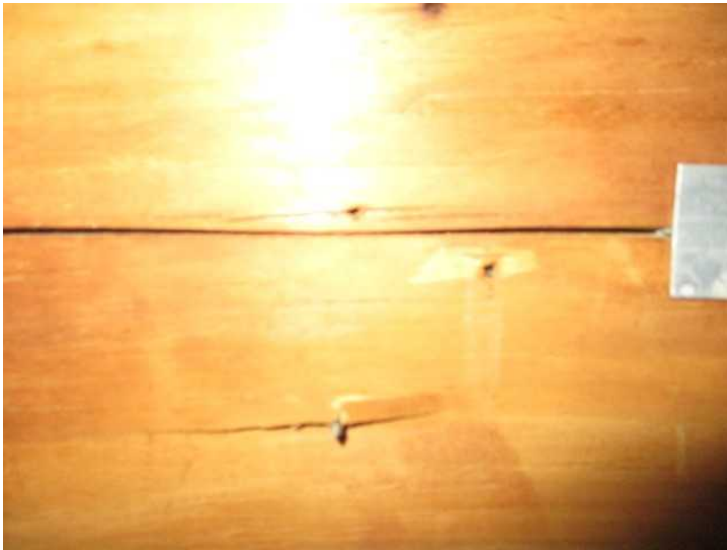
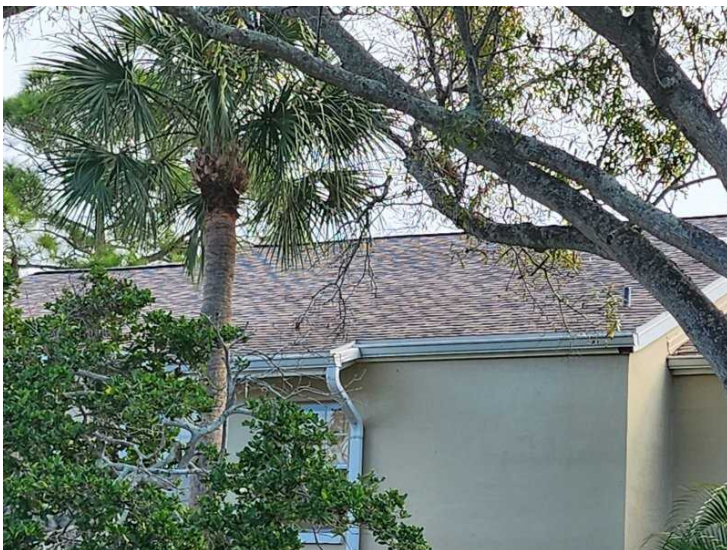
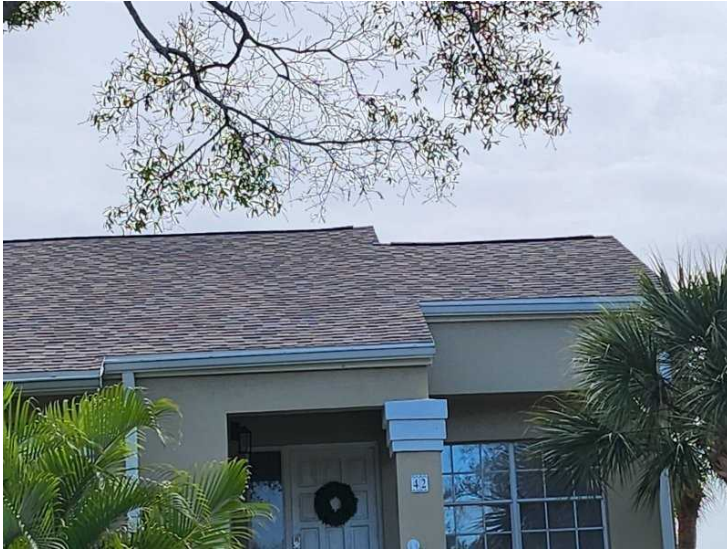
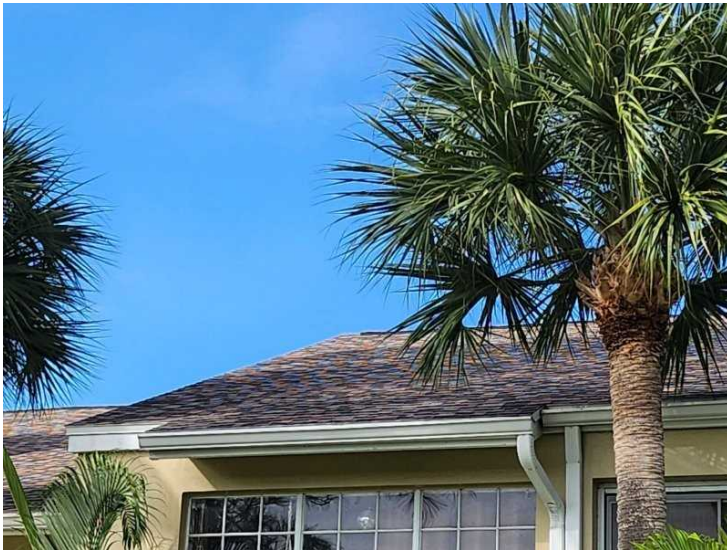
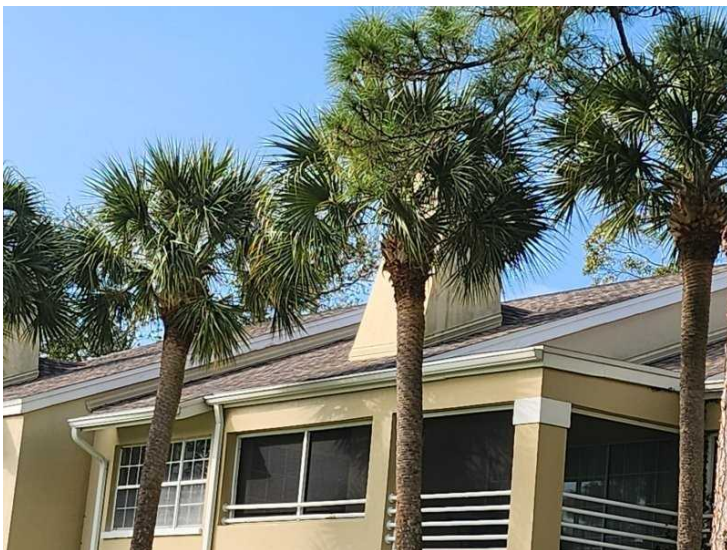
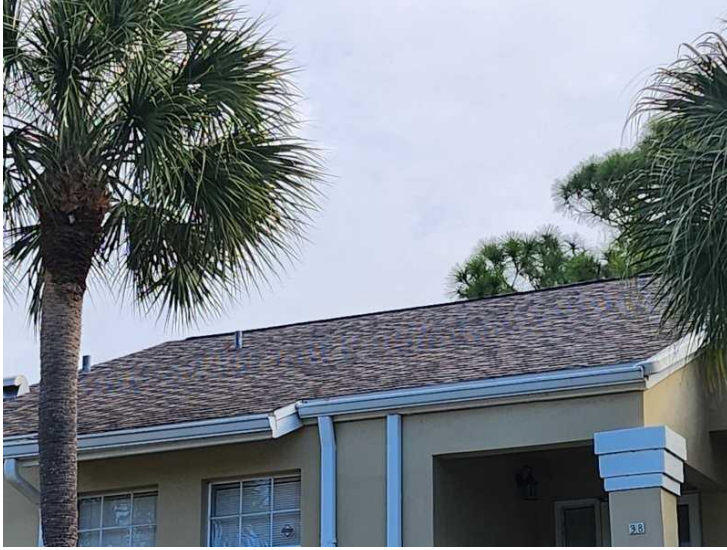
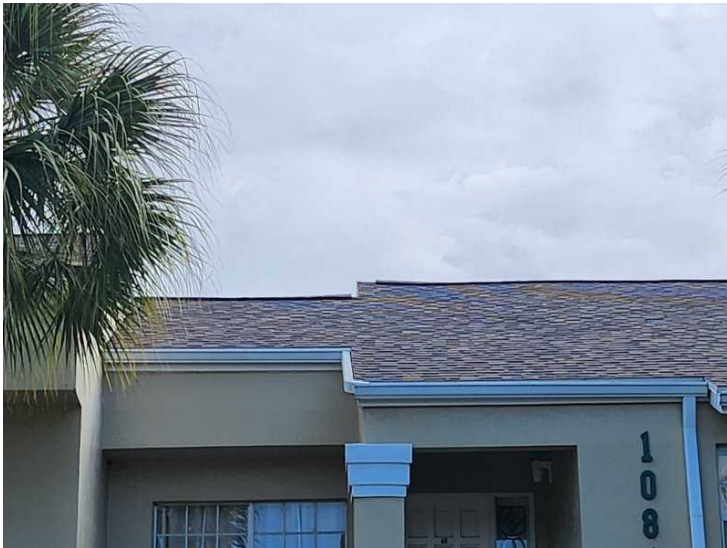
Roof Construction

| <b>3. Roof Deck Attachment:</b><br>Comments: | <b>Level C</b><br>Inspection verified 1/2" plywood roof deck attached with 8d nails at a minimum 6" on the edge & 6" in the field. |
| <b>4. Roof to Wall Attachment:</b><br>Comments: | <b>Clips</b><br>Inspection verified hurricane clips fastened with a minimum of three nails. |
| <b>6. SWR:</b><br>Comments: | <b>Yes</b><br>SWR was verified at time of inspection. The Secondary Water Resistance verified is a self-adhering peel and stick. |
