## Windstorm Mitigation Report (OIR-B1-1802)

The Cloisters At Bardmoor Condominium Association, Inc.

10823 Indian Hills Ct, Units 29-34

As of 01-05-2026 | FPAT File# MUD2525974

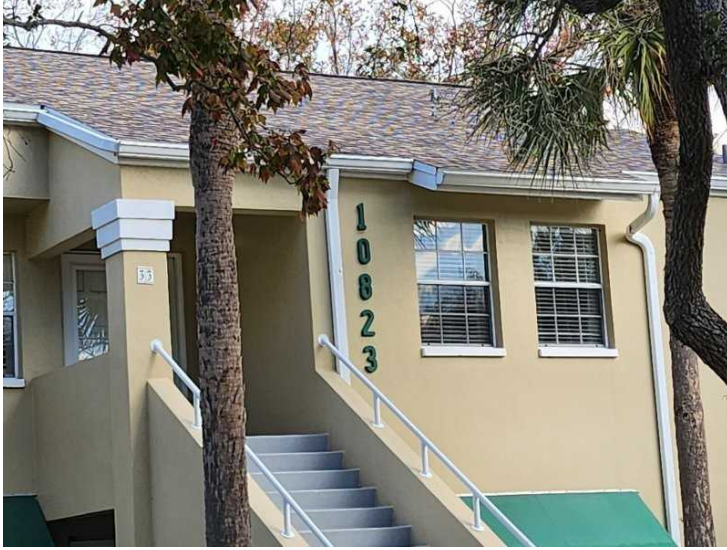
Address Verification

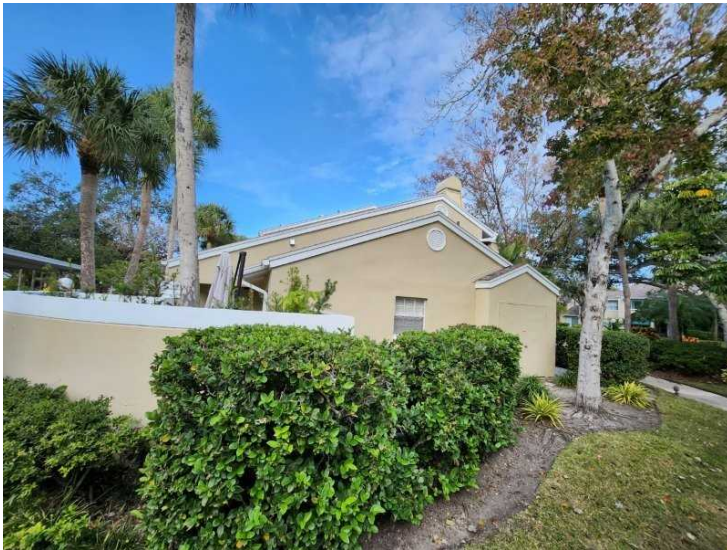
| <b>5. Roof Geometry:</b><br>Comments: | <b>Other Roof</b><br>Inspection verified a gable roof shape. |

Exterior Elevation

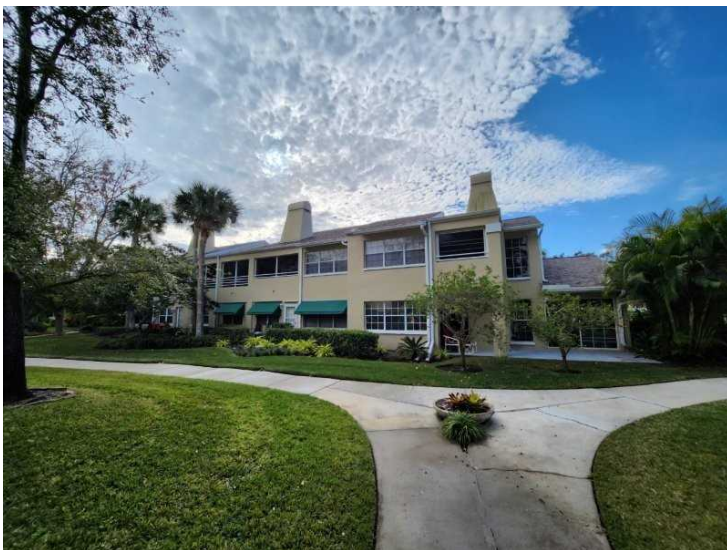
Exterior Elevation

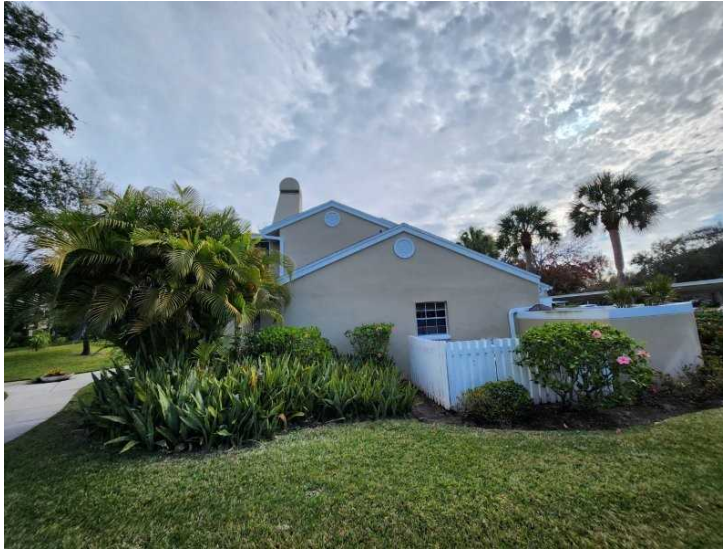
| <b>2. Roof Covering:</b><br>Comments: | <b>FBC Equivalent</b><br>The roof covering was replaced in 2020. The roof permit was confirmed and the permit number is EBP-20-00372. This roof was verified as meeting the building code requirements outlined on the mitigation affidavit. |

Record EBP-20-00372:  
Express Building Permit  
Record Status: **Finalized**  
Expiration Date: 05/22/2021

**Project Description:**  
RE-ROOF W/OC PEEL & STICK (FL9777-812) AND OWENS  
CORNING SHINGLES (FL10675-R15) 67 SQUARES 5/12  
SLOPE ADD 4 SQ FLAT CERTAINTED SA BASE, MID & CAP  
FL2355-R25

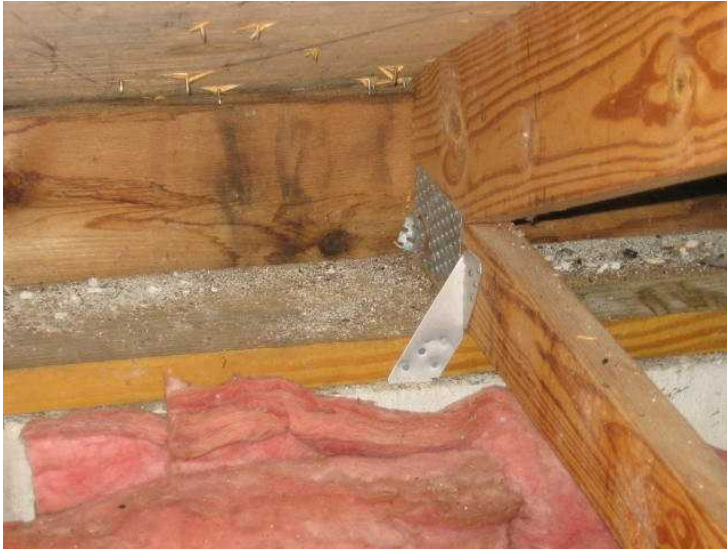
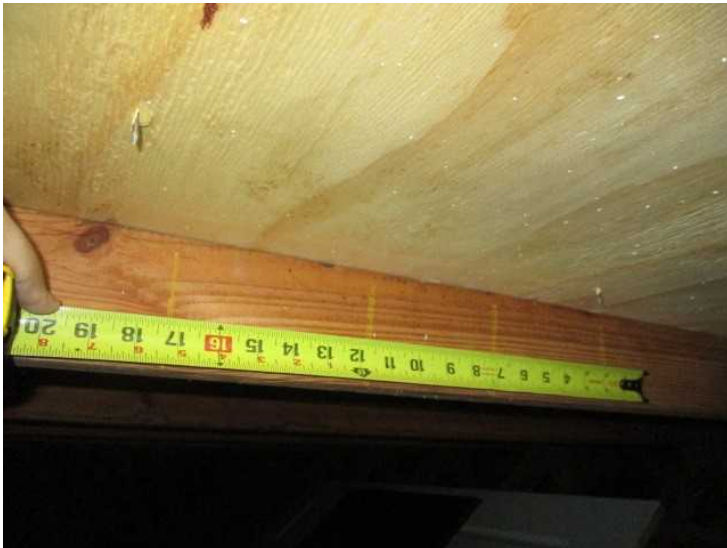
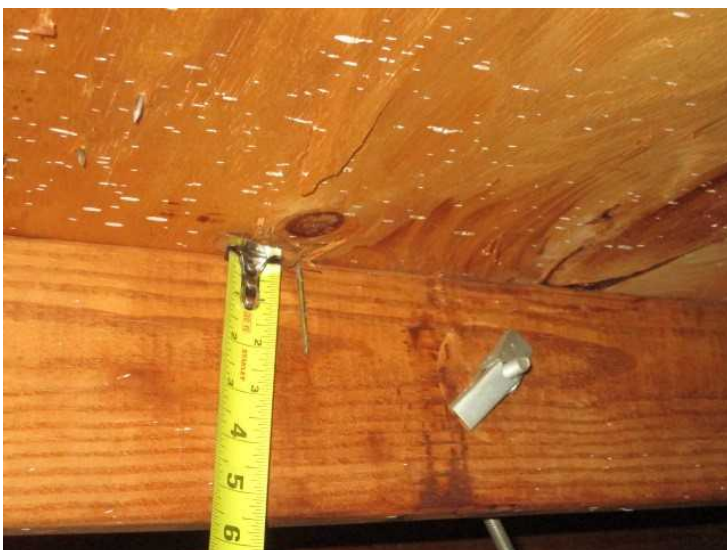
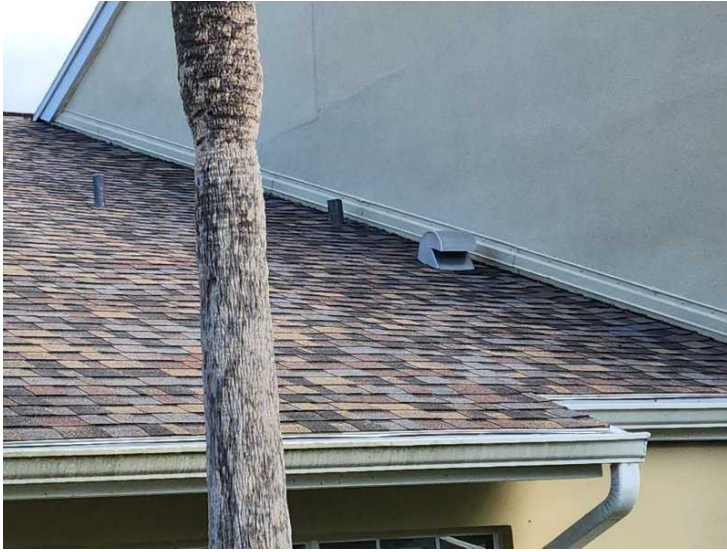
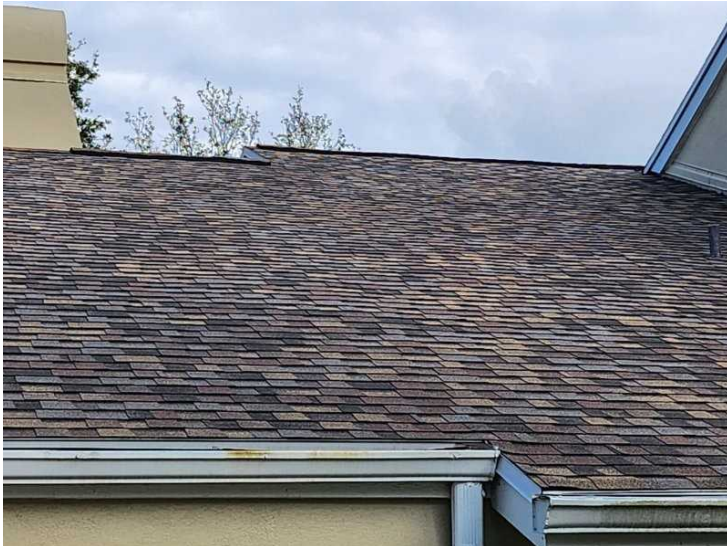
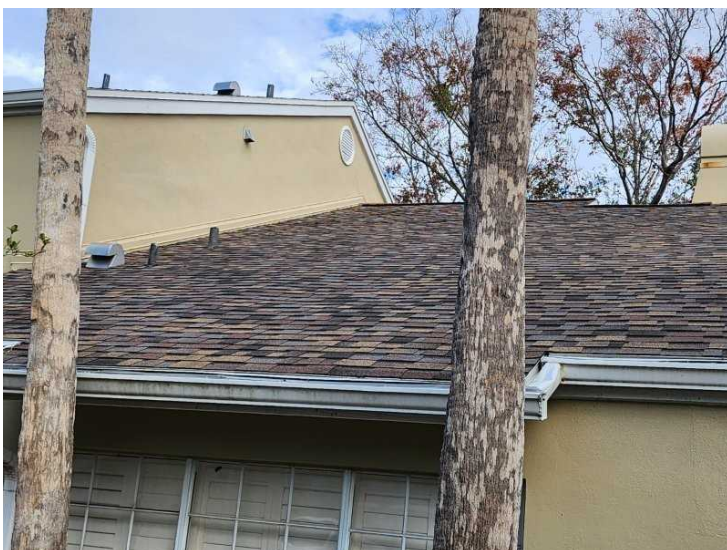
| <b>3. Roof Deck Attachment:</b><br>Comments: | <b>Level C</b><br>Inspection verified 1/2" plywood roof deck attached with 8d nails at a minimum 6" on the edge & 6" in the field. |
| <b>4. Roof to Wall Attachment:</b><br>Comments: | <b>Clips</b><br>Inspection verified hurricane clips fastened with a minimum of three nails. |
| <b>6. SWR:</b><br>Comments: | <b>Yes</b><br>SWR was verified at time of inspection. The Secondary Water Resistance verified is a self-adhering peel and stick. |
