## Windstorm Mitigation Report (OIR-B1-1802)

The Cloisters At Bardmoor Condominium Association, Inc.

10835 Indian Hills Ct, Units 19-24

As of 01-05-2026 | FPAT File# MUD2525974

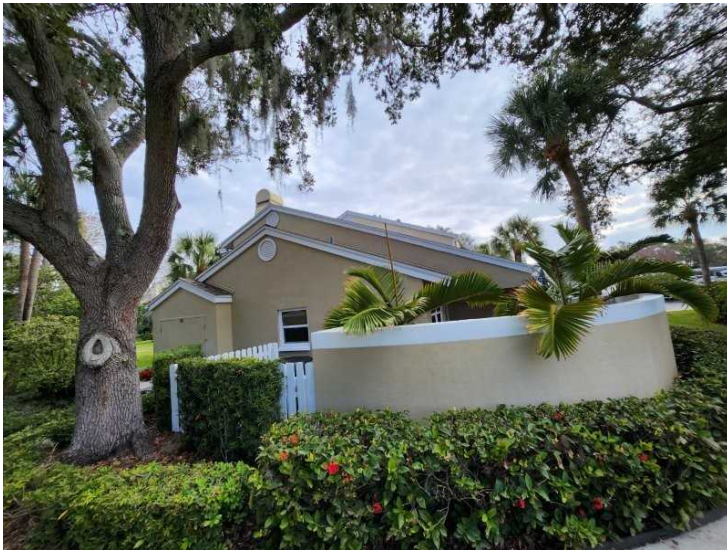
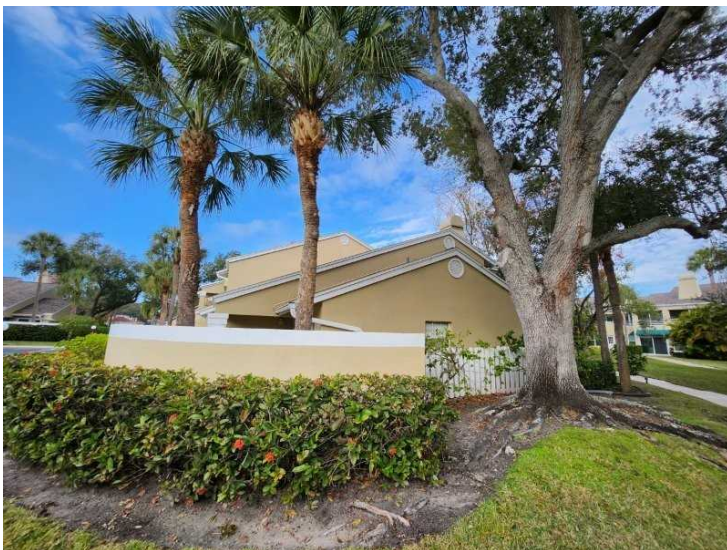
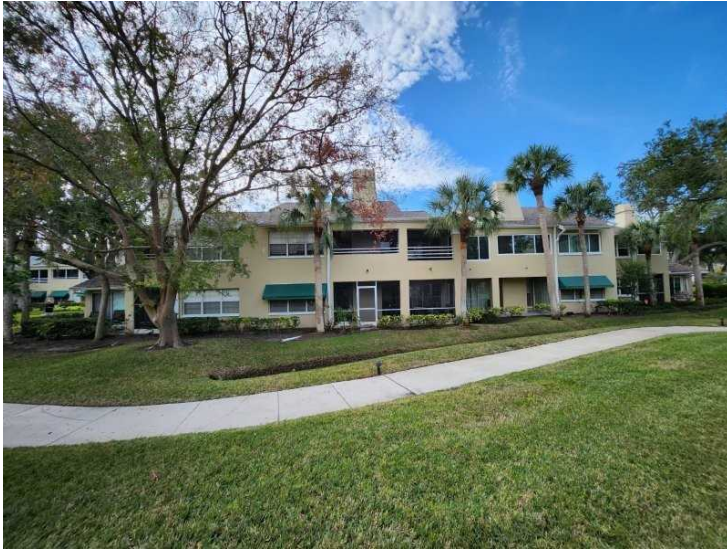
Exterior Elevation

| <b>5. Roof Geometry:</b><br>Comments: | <b>Other Roof</b><br>Inspection verified a gable roof shape. |
| <b>7. Opening Protection:</b><br>Comments: | <b>None or Some Glazed Openings</b><br>No opening protection verified at the time of inspection. |

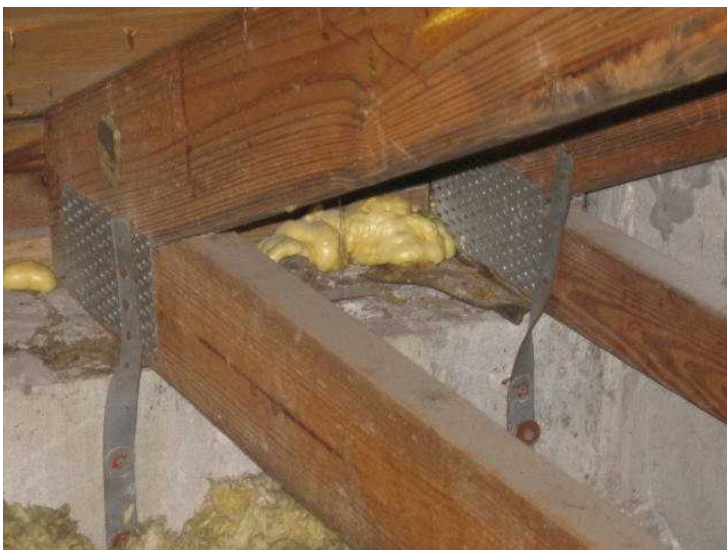
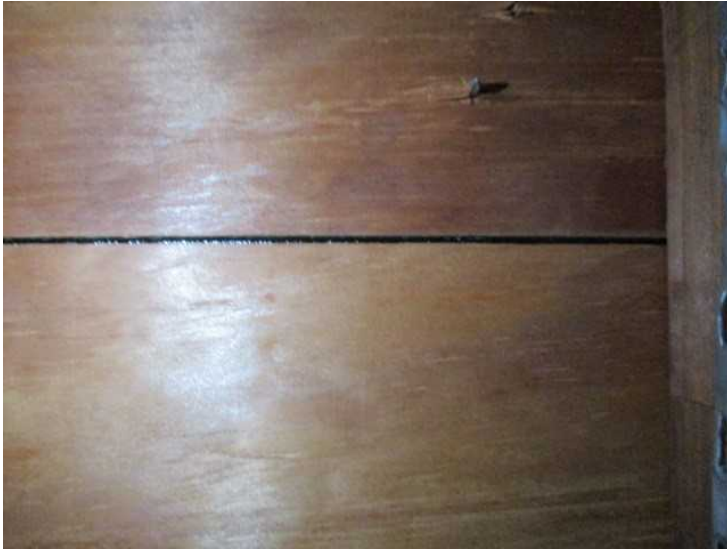
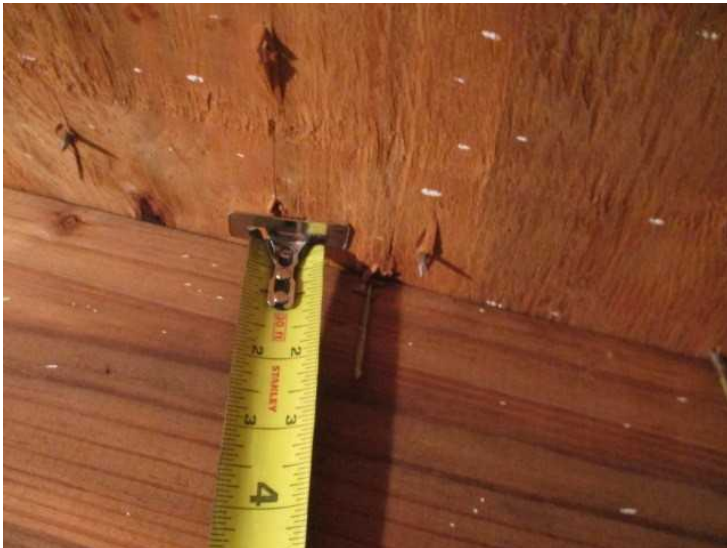
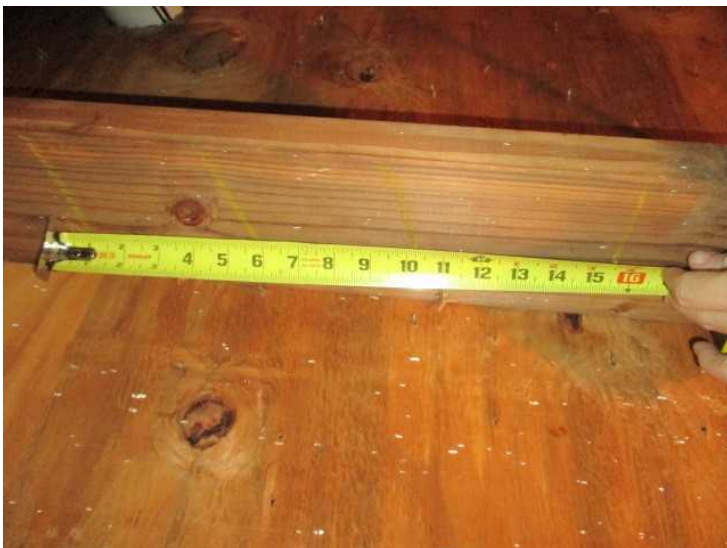
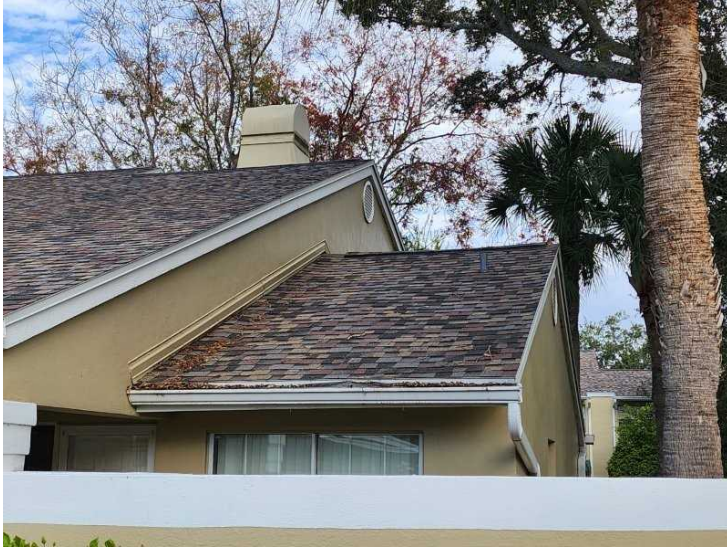
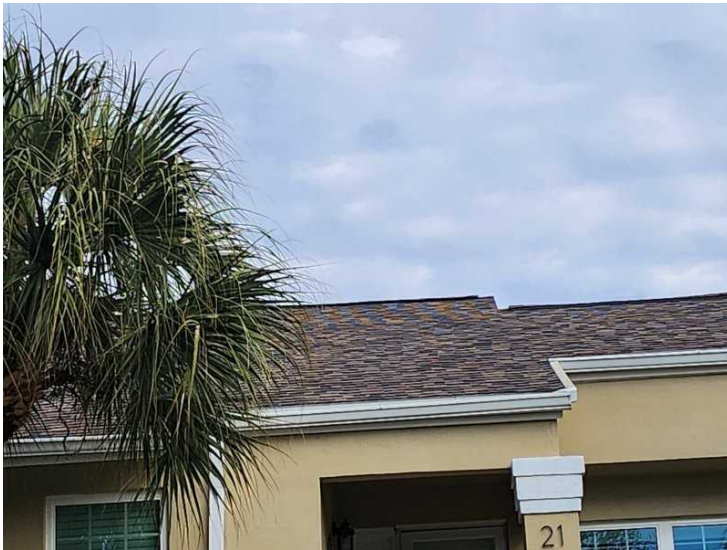
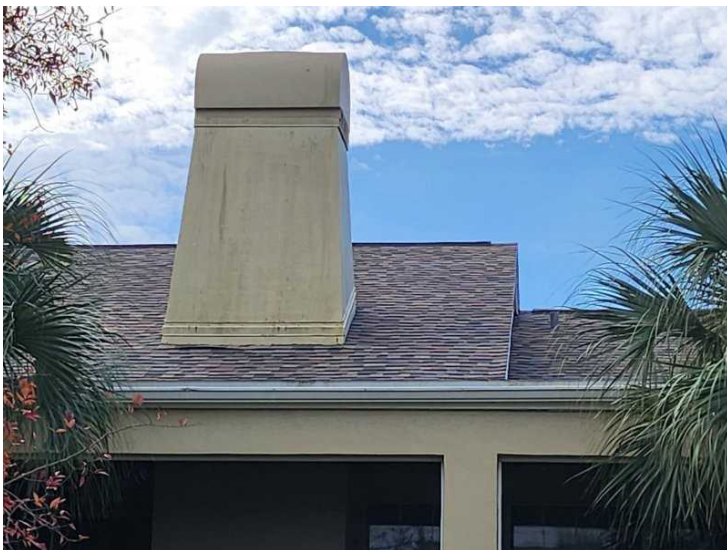
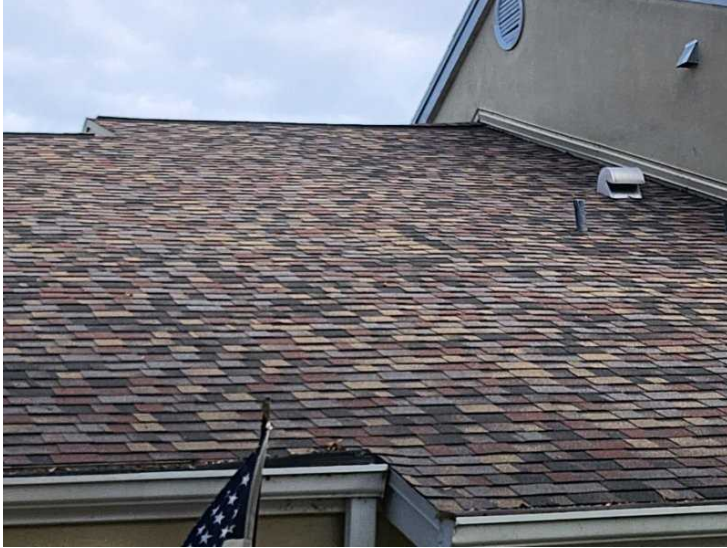
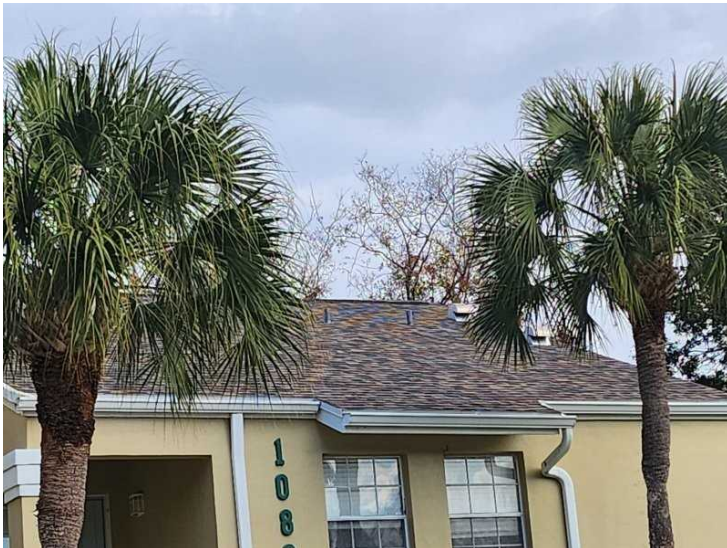
Roof Construction

| <b>3. Roof Deck Attachment:</b><br>Comments: | <b>Level C</b><br>Inspection verified 1/2" plywood roof deck attached with 8d nails at a minimum 6" on the edge & 6" in the field. |
| <b>4. Roof to Wall Attachment:</b><br>Comments: | <b>Clips</b><br>Inspection verified a majority of embedded straps with a minimum of 3 nails. The remaining straps were connected to the wall with at least 2 nails from a powder actuated nail gun and a minimum of three nails on the truss. |
| <b>6. SWR:</b><br>Comments: | <b>Yes</b><br>SWR was verified at time of inspection. The Secondary Water Resistance verified is a self-adhering peel and stick. |
