## Windstorm Mitigation Report (OIR-B1-1802)

The Cloisters At Bardmoor Condominium Association, Inc.

10847 Indian Hills Ct, Units 25-28

As of 01-05-2026 | FPAT File# MUD2525974

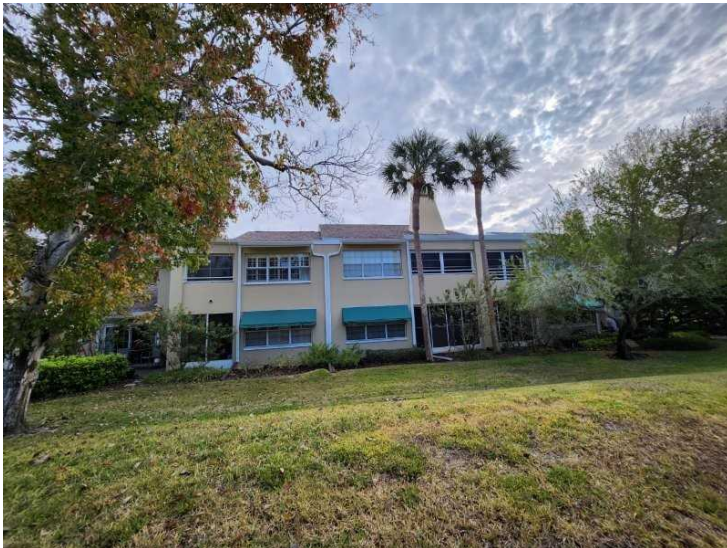
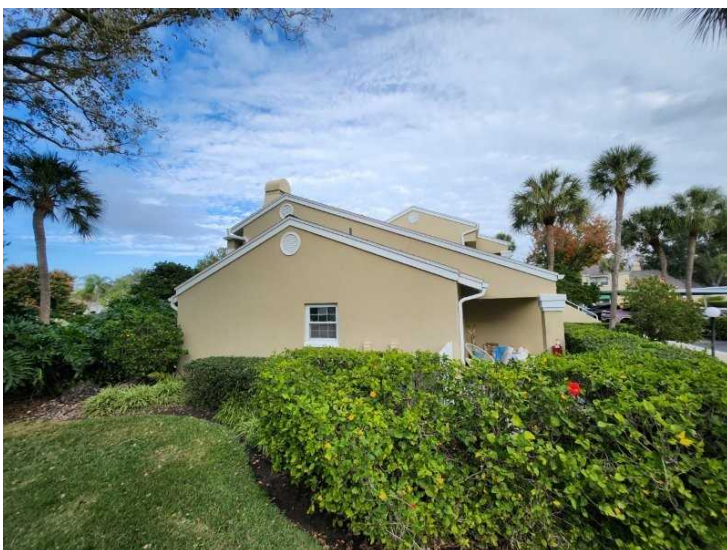
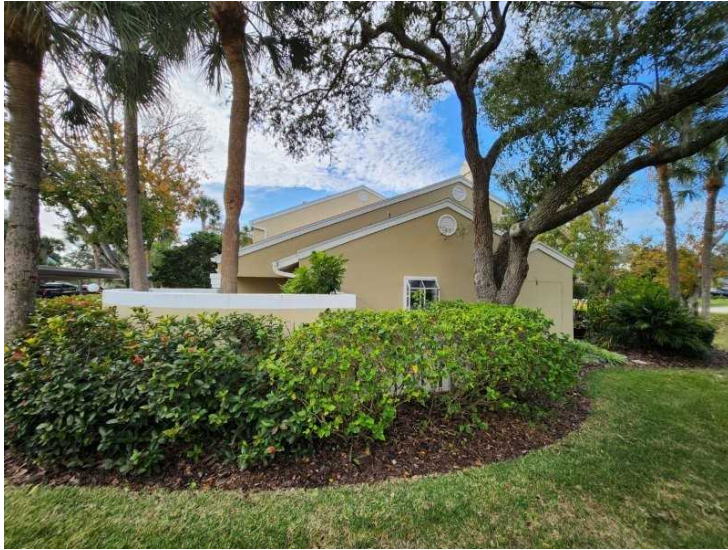
| <b>5. Roof Geometry:</b><br>Comments: | <b>Other Roof</b><br>Inspection verified a gable roof shape. |

Exterior Elevation

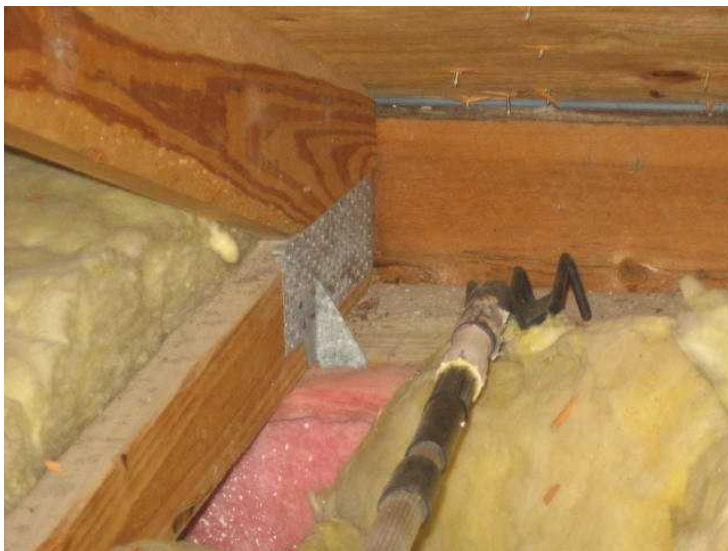
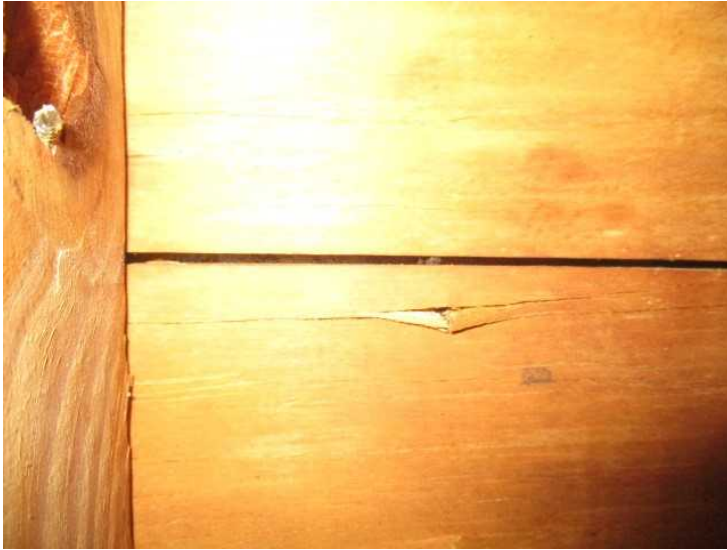
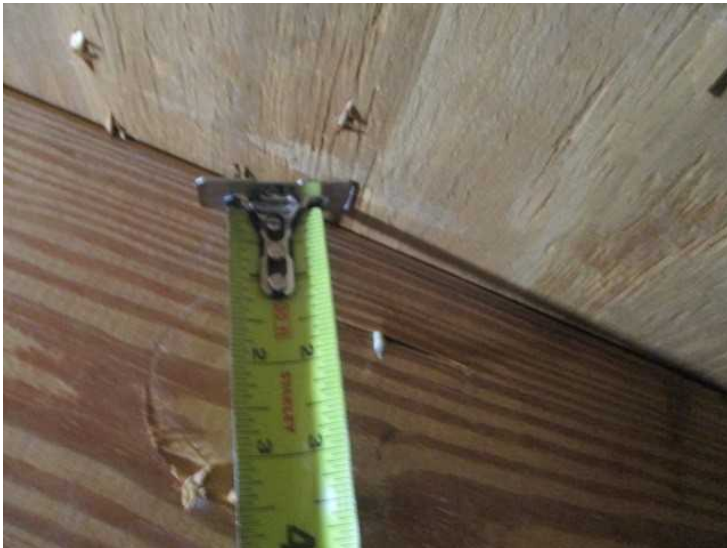
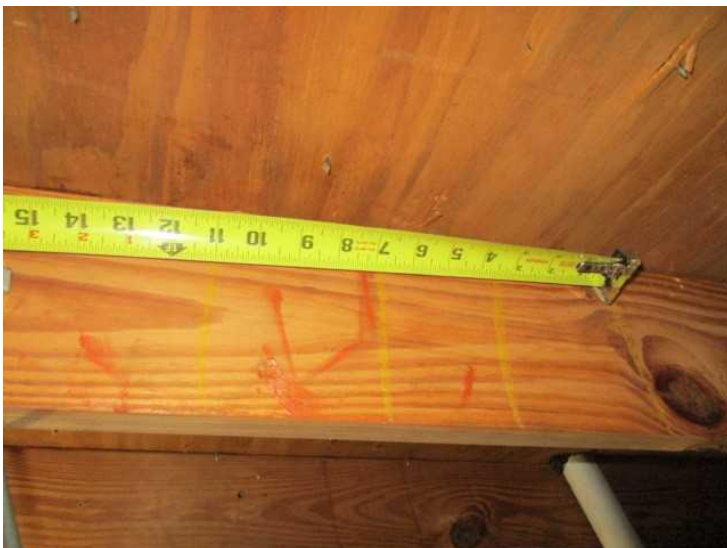
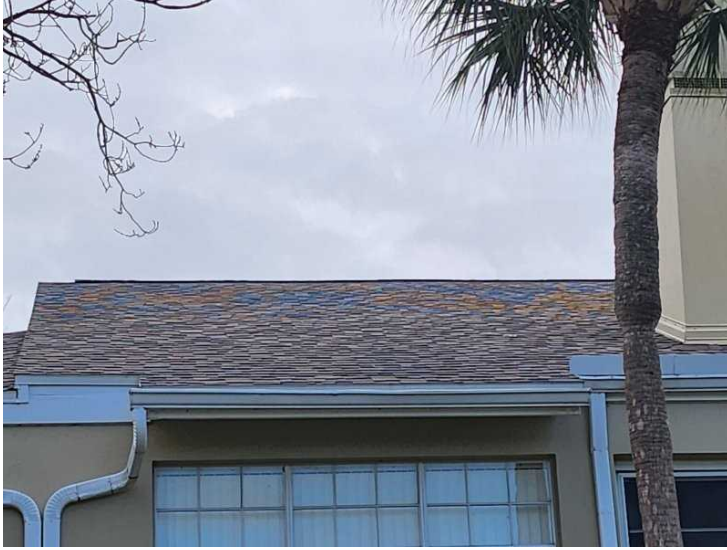
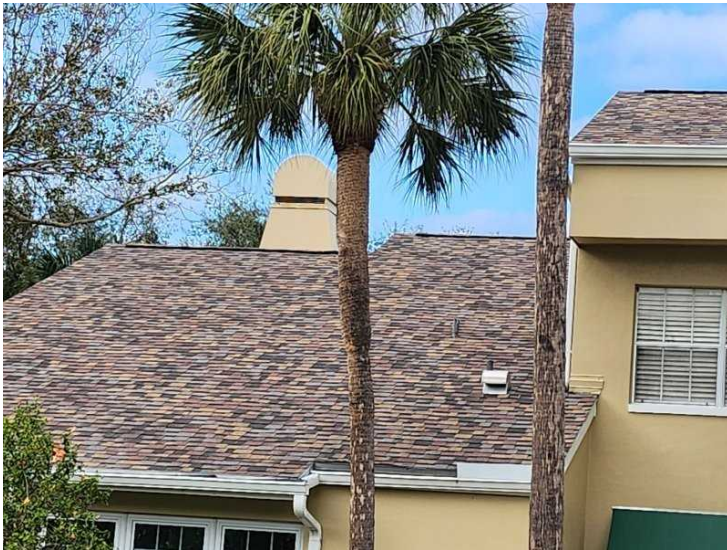
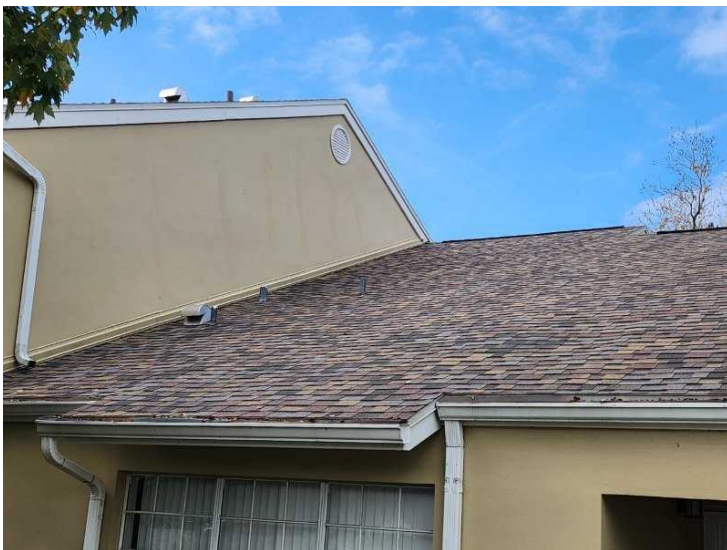
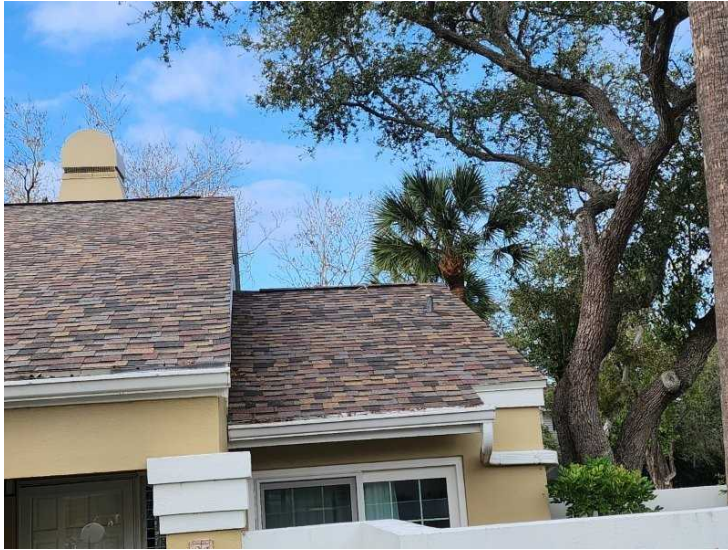
| <b>3. Roof Deck Attachment:</b><br>Comments: | <b>Level C</b><br>Inspection verified 1/2" plywood roof deck attached with 8d nails at a minimum 6" on the edge & 6" in the field. |
| <b>4. Roof to Wall Attachment:</b><br>Comments: | <b>Clips</b><br>Inspection verified hurricane clips fastened with a minimum of three nails. |
| <b>6. SWR:</b><br>Comments: | <b>Yes</b><br>SWR was verified at time of inspection. The Secondary Water Resistance verified is a self-adhering peel and stick. |

Roof Construction
