## Windstorm Mitigation Report (OIR-B1-1802)

The Cloisters At Bardmoor Condominium Association, Inc.

8395 Meadow Brook Dr, Units 1-5

As of 01-05-2026 | FPAT File# MUD2525974

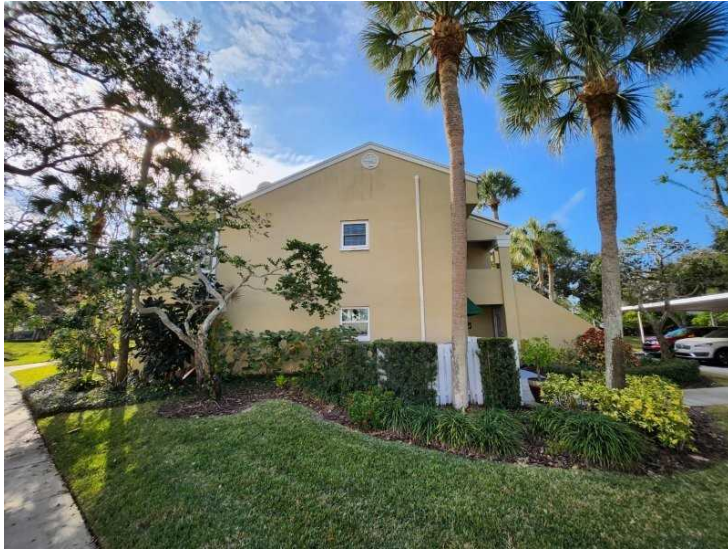
Roof Permit  
Information

| <b>2. Roof Covering:</b><br>Comments: | <b>FBC Equivalent</b><br>The roof covering was replaced in 2020. The roof permit was confirmed and the permit number is EBP-20-00374. This roof was verified as meeting the building code requirements outlined on the mitigation affidavit. |

| <input type="checkbox"/> | 10/20/2020 | Express Building Permit | <a href="#">FMP-25-20374</a> | Finalist |
| <div>RE ROOF W/ OC PEEK<br/>&amp; STICK (FL1977-412)<br/>AND CHENG<br/>CORNING SHINGLES<br/>(FL19A79-411) 11<br/>SQUARES 14/12 SLOPE<br/>ADD 300 FLAT<br/>CERTANTIFIED 3A<br/>BASE, MD &amp; CAP<br/>FL2330-423</div> | | | | |
